Medical Devices: The Therac-25*

Nancy Leveson
University of Washington

1 Introduction

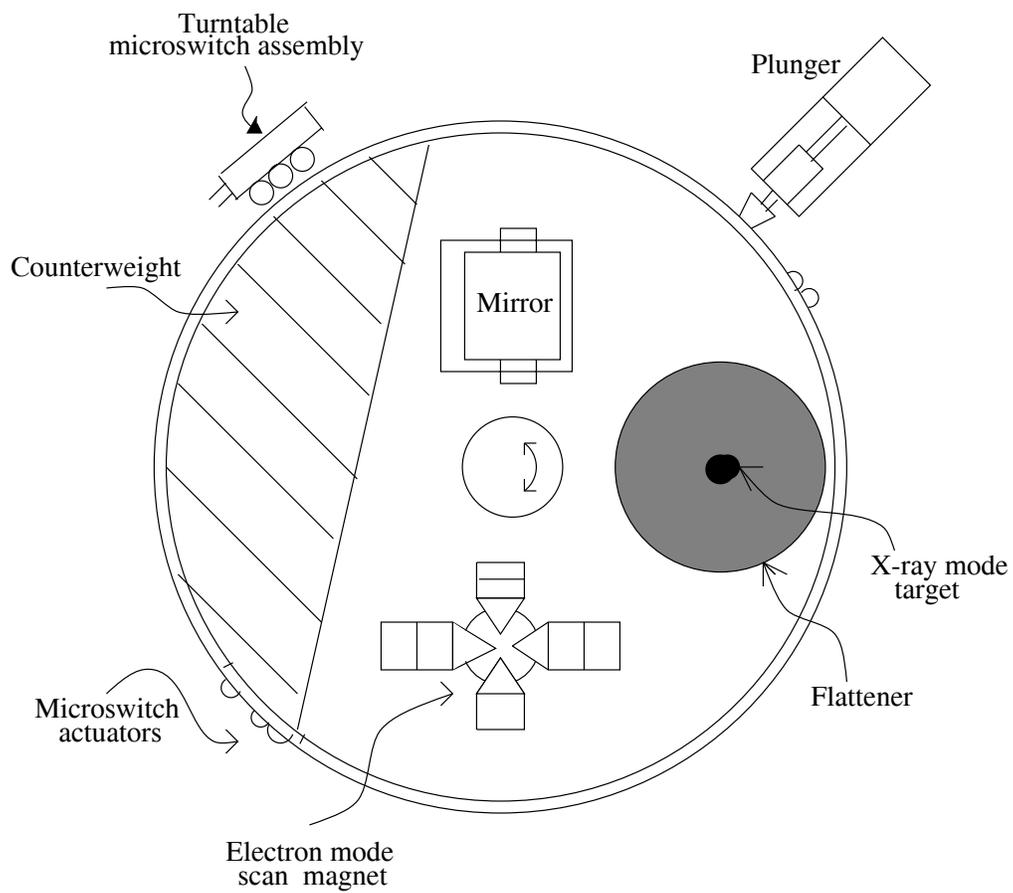
Figure 1: Upper turntable assembly.

Turntable Positioning. The Therac-25 turntable design plays an important role in the accidents. The upper turntable (see Figure 1) rotates accessory equipment into the beam path to produce two therapeutic modes: electron mode and photon mode. A third position (called the field light position) involves no beam at all, but rather is used to facilitate correct positioning of the patient. Because the accessories appropriate to each mode

are physically attached to the turntable, proper operation of the Therac-25 is heavily dependent on the turntable position, which is monitored by three microswitches.

AECL could not reproduce the malfunction that had occurred, but suspected a transient failure in the microswitch used to determine the turntable position. During the investigation of the accident, AECL hardwired the error conditions they assumed were necessary for the malfunction and, as a result, found some turntable positioning design weaknesses and potential mechanical problems.

The computer senses and controls turntable position by reading a 3-bit signal about the status of three microswitches in the turntable switch assembly. Essentially, AECL determined that a 1-bit error in the microswitch codes (which could be caused by a single open-circuit fault on the switch lines) could produce an ambiguous position message to the computer. The problem was exacerbated by the design of the mechanism that extends a plunger to lock the turntable when it is in one of the three cardinal positions: The plunger could be extended when the turntable was way out of position, thus giving a second false position indication. AECL devised a method to indicate turntable position that tolerated a 1-bit error so that the code would still unambiguously reveal correct position with any one microswitch failure.

The modifications specified in the Symonds report included redesigning the microswitch and changing the way the computer handled malfunction conditions. In particular, treatment was to be terminated in the event of a dose-rate malfunction, giving a treatment “suspend.” This change would have removed the option to proceed simply by pressing the \textcircled{P} key. The report also made recommendations regarding collimator test procedures and message and command formats. A November 8, 1985 letter, signed by the director of the Canadian RPB, asked that AECL make changes to the Therac-25 based on the Symond’s report “to be in compliance with the RED act.”

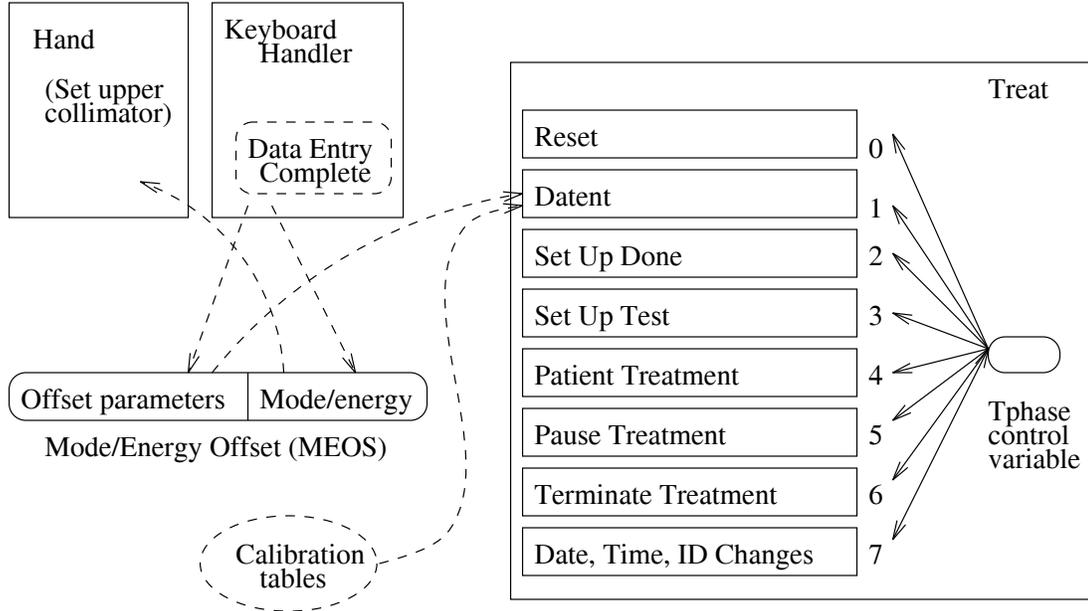
Figure 3: Tasks and subroutines in the code blamed for the Tyler accidents.

The treatment monitor task (Treat) controls the various phases of treatment by executing its eight subroutines. The treatment phase indicator variable (Tphase) is used to determine which subroutine should be executed (Figure 3). Following the execution of a particular subroutine, Treat reschedules itself.

But this is not the only problem. Upon exit from the Magnet subroutine, the data entry subroutine (Datent) checks the Data Entry Complete variable. If it indicates that data entry is complete, Datent sets Tphase to 3 and Datent is not entered again. If it is not set, Datent leaves Tphase unchanged, which means it will eventually be rescheduled. But the Data Entry Complete variable only indicates that the cursor has been down to the command line, not that it is still there. A potential race condition is set up. To fix this, AECL introduced another shared variable controlled by the keyboard handler task that indicates the cursor is not positioned on the command line. If this variable is set, then prescription entry is still in progress and the value of Tphase is left unchanged.

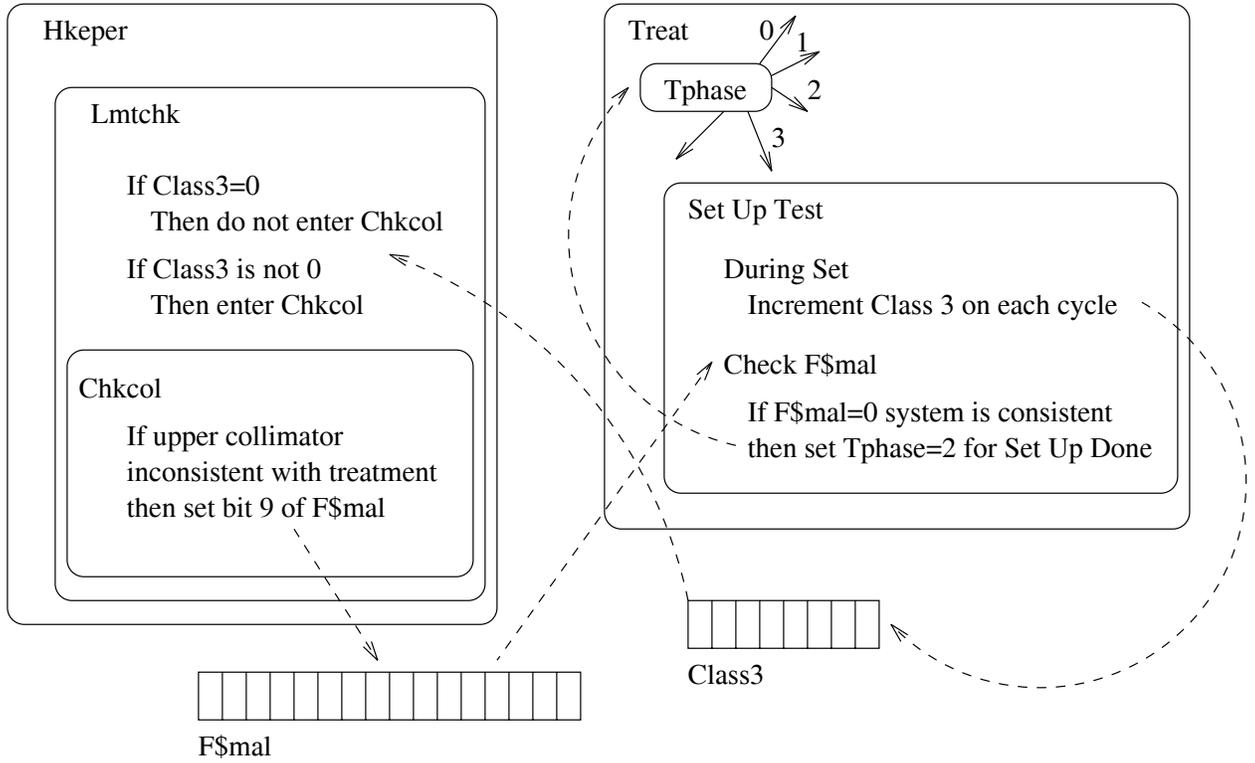
Figure 4: The Yakima software flaw.

The second Yakima accident was again attributed to a type of race condition in the software — this one allowed the device to be activated in an error setting (a “failure” of a software interlock). The Tyler accidents were related to problems in the data-entry routines that allowed the code to proceed to Set Up Test before the full prescription had been entered and acted upon. The Yakima accident involved problems encountered later in the logic after the treatment monitor Treat reaches Set Up Test.

The overexposure occurred when the operator hit the “set” button at the precise moment that Class3 rolled over to zero. Thus, Chkcol was not executed and F\$mal was not set to indicate that the upper collimator was still in the field-light position. The software turned on the full 25 MeV without the target in place and without scanning. A highly concentrated electron beam resulted, which was scattered and deflected by the stainless
